## September/October 2003

### A New Solution for an Old Problem

*An innovative use of anchor blocks and tiebacks may solve a landslide condition on a steep roadside slope in Tennessee.*

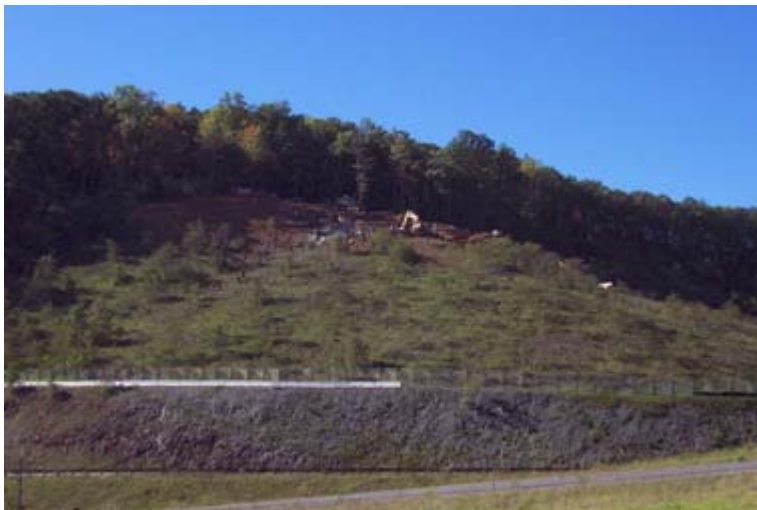
This view of the construction site from the interchange shows the concrete barriers and fence that were installed to prevent debris from entering the roadway below.

Prior to the start of construction, EFLHD installed concrete Jersey barriers on the affected slope along US 25E. As an additional precaution, the contractor installed a high chain-link fence on top of the barriers. The fence prevented the numerous boulders that were dislodged during construction from overtopping the Jersey barriers and falling onto the road below.

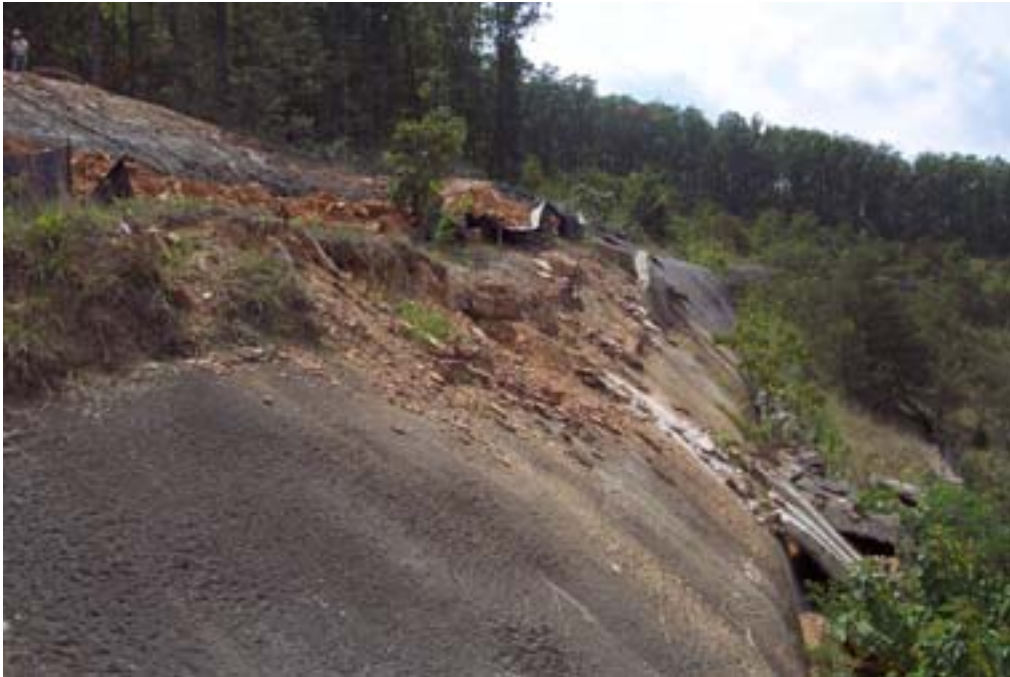
In addition, an earth ripple 0.9 meters (3 feet) high was prominent along the US 58 ramp and the US 25E toe of the slide at an elevation 479 meters (1,570 feet). The earth ripple also affected a nonstructural section of the soil nail wall by spalling off a large portion of shotcrete. Slope monitoring data revealed continuous slide movements accelerating during the spring, tapering off in the drier late summer and fall months.

This close-up shows the damage to the existing soil nail wall caused by the slide.

The second step was the actual bidding. The contractor that won the bid would perform the drilling for the tieback anchors and install them, place the shotcrete leveling pads for the anchor blocks, and repair the existing soil nail wall. Several subcontractors would construct the haul road, do the excavation and backfill, seat the anchor blocks, and place the topsoil after final grading.

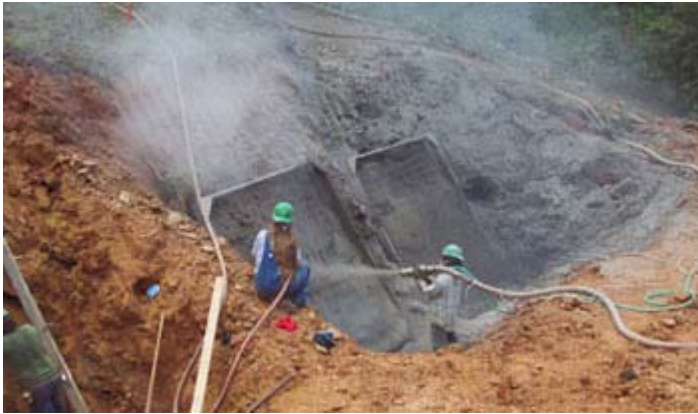
Workers are spraying shotcrete for one of the pads.

Then the crew laid out a grid of 13 columns of anchor blocks in 10 rows on the slope. Using an excavator, the crew cut a bench into the slope and immediately placed the shotcrete leveling pads against the slope. After a shotcrete leveling

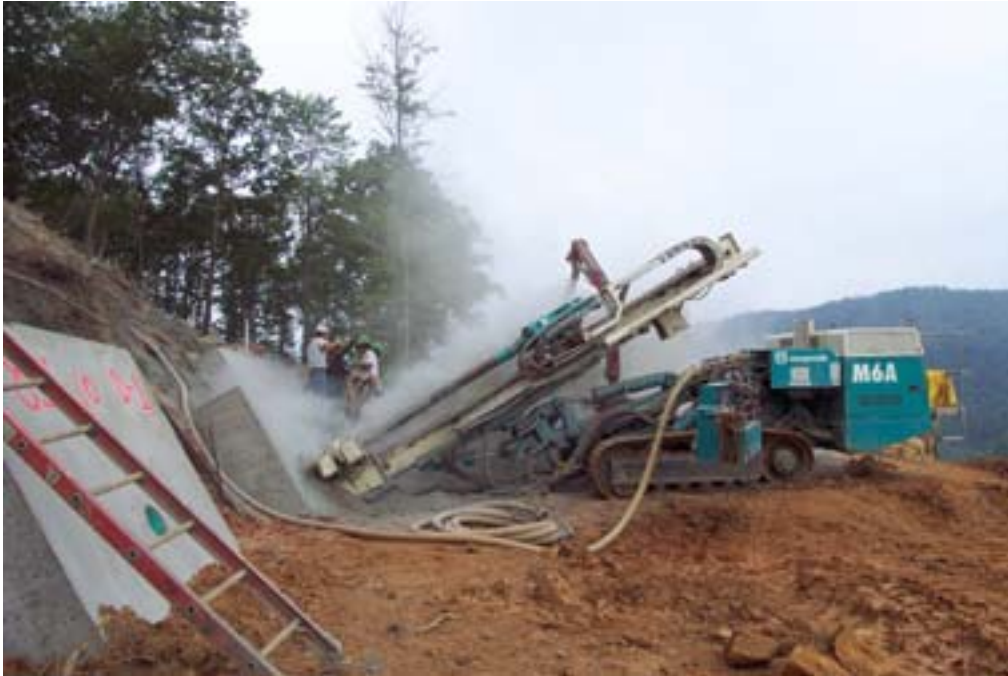
The contractor is drilling for the ground anchors. Note the anchor block set prior to drilling.

A compressed-air rig drilled holes for the tiebacks, which varied in length from 26 to 32 meters (85 to 105 feet). An excavator and boom fork lowered the tieback tendons into the holes, and the contractor then grouted the tendons and cast grout cubes. After the grout cubes reached the required strength (usually 3 days), the contractor stressed the tiebacks to 100 percent of design load. Typically, little to no movement of the anchor blocks was observed during stressing.

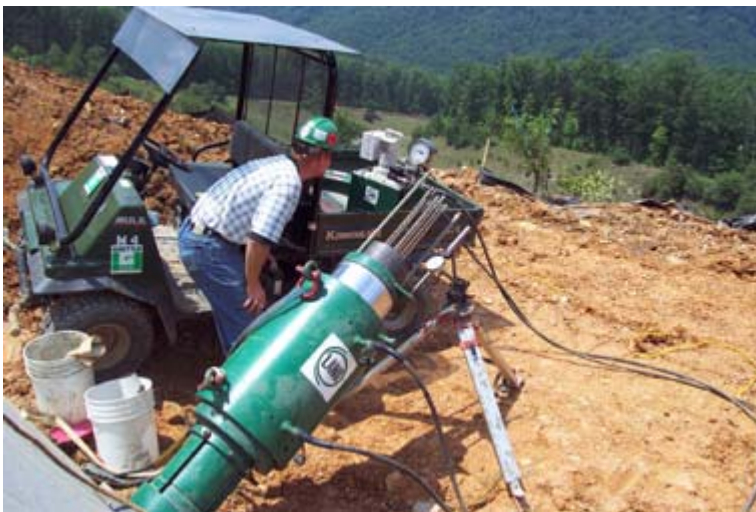
Proof loading an installed ground anchor.

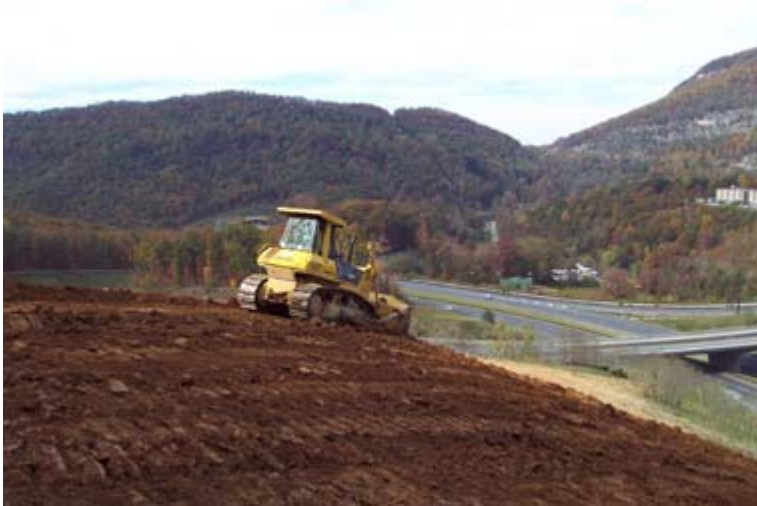
The contractor placed fill material over the anchors and is shown restoring the site to its original contours.

Due to the unusually dry summer, all the tiebacks were completed by early October 2001. An excavator and a bulldozer recontoured the slope and added topsoil prior to seeding. Three permanent piezometers and inclinometers were installed, and the access road was restored to the original contours—well ahead of schedule.
